# REFERENCES

Trenchless rehabilitation of buildings and properties

## The market for in-house rehabilitation encompasses 47.5 million buildings

### Rehabilitation of waste water pipes without cutting and demolition work inside buildings using the example of Finland

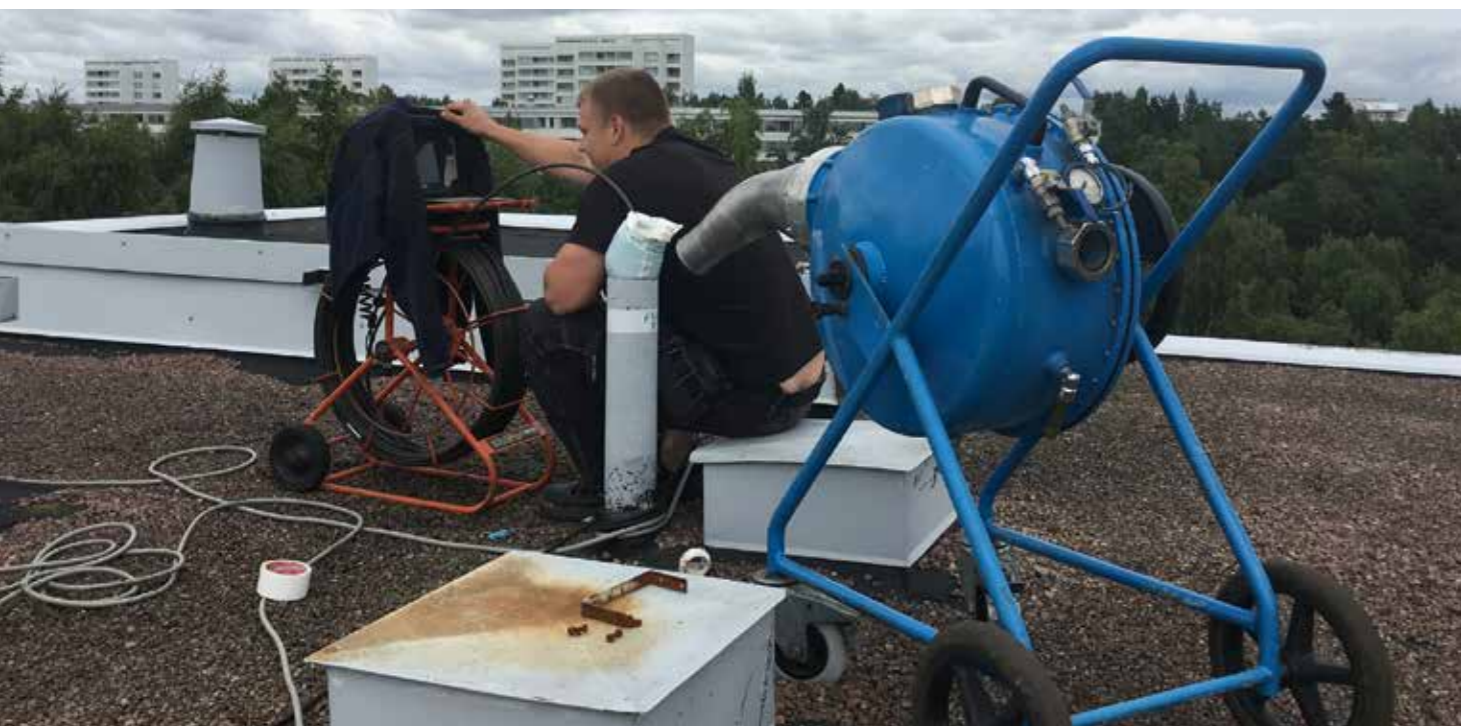
Figure 1: BRAWOLINER® rehabilitation of downpipes above the roofs of Helsinki

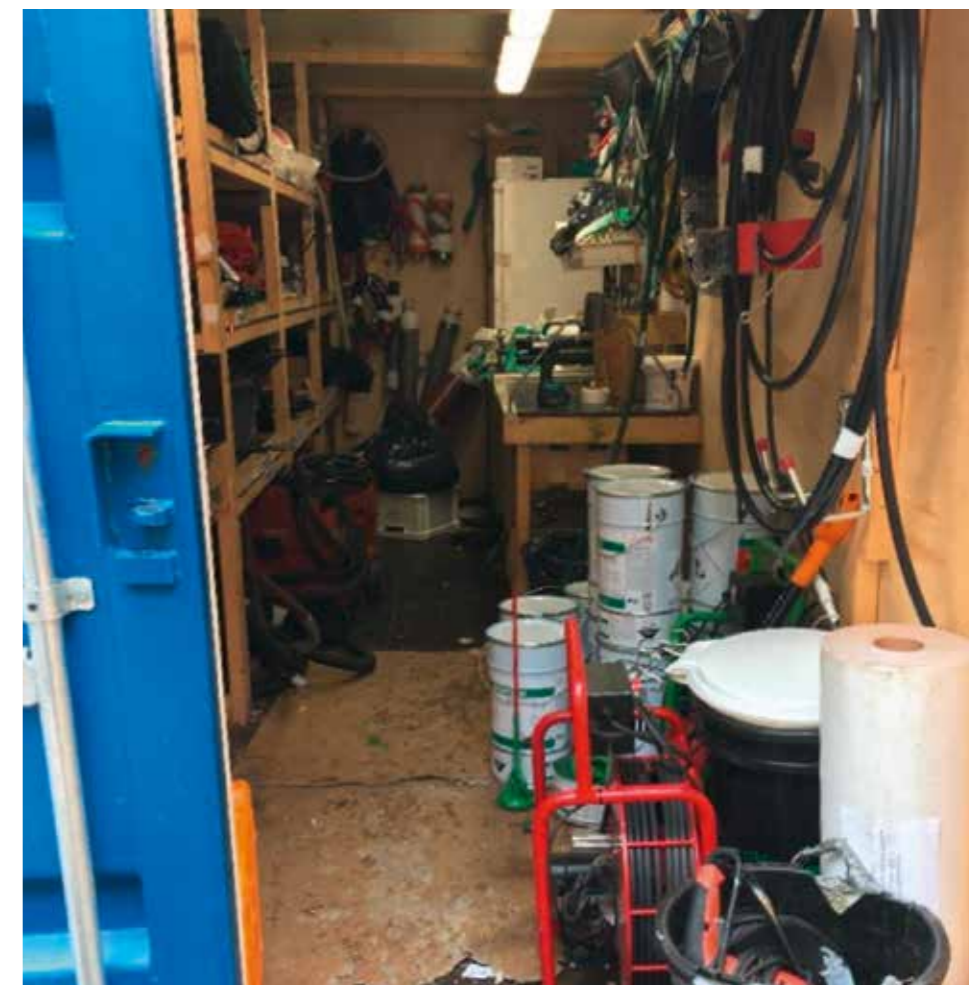
Figure 6: Site container with technical equipment on the construction site in Helsinki-Pehlajasto

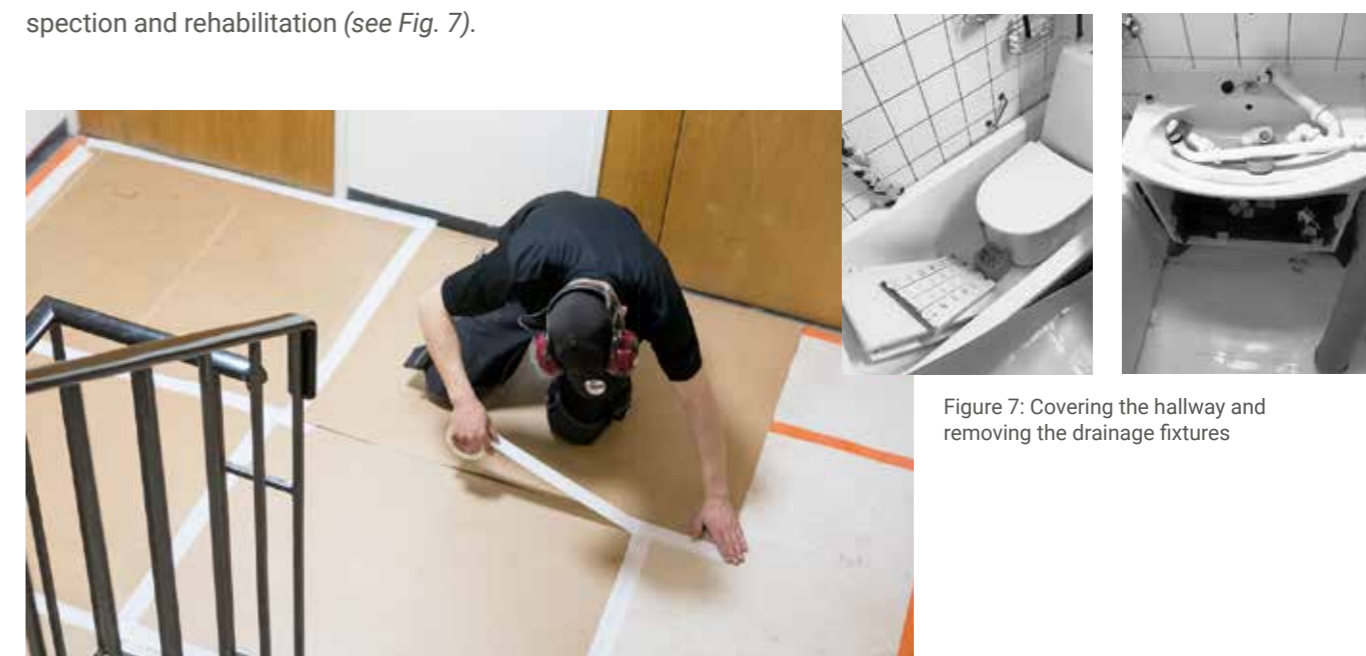
Figure 7: Covering the hallway and removing the drainage fixtures

Before the corridors and apartments are covered, previous damage and abnormalities are photographed for evidence purposes. After that the premises are completely covered to protect them using cardboard or protective paper among other things. All drainage fixtures are then taken out of service and covered, and the accesses are cleared for cleaning, inspection and rehabilitation (see Fig. 7).

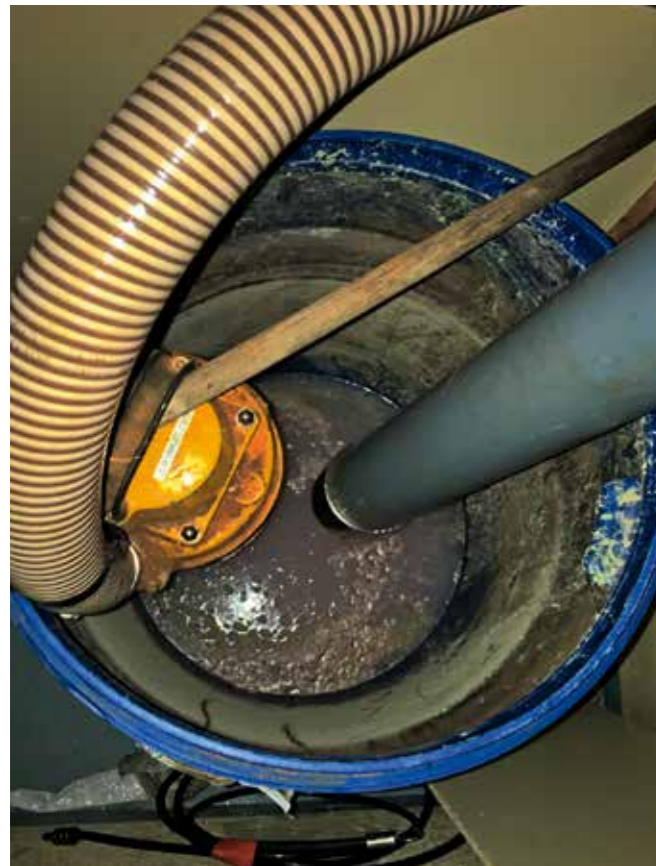
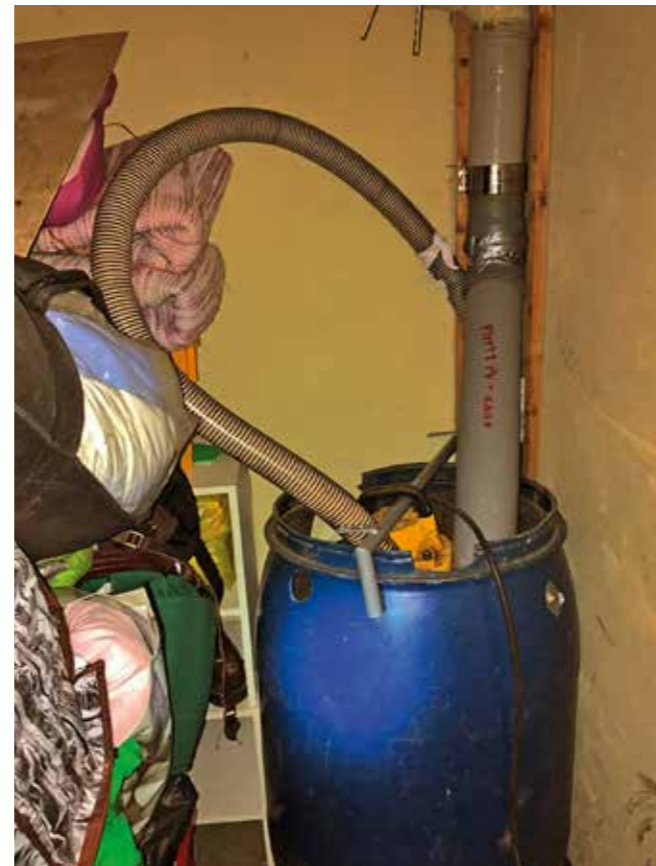
Figure 8 and 8a: Collecting the solids when cleaning the drainage systems

In order to avoid blockages in the building connection duct, the pipes in the basement area are capped and the waste water is fed into large drums during cleaning (see Fig. 8 and 8a). The solids settle in the bottom of the tank and the waste water on top is pumped towards the connection duct.

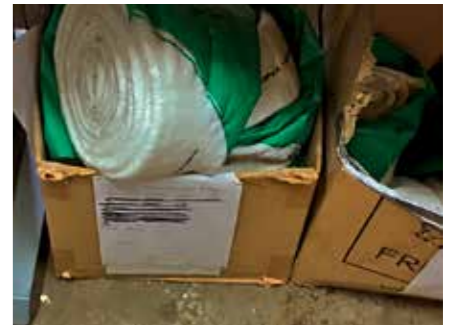
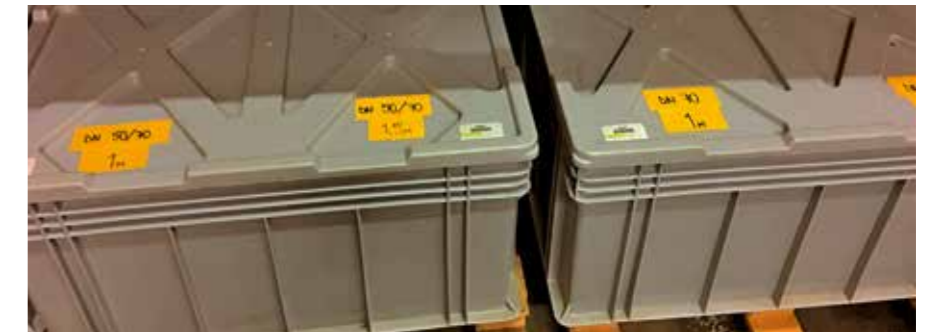
Figure 9 and 9a: Pre-cut pipe liners for the construction project

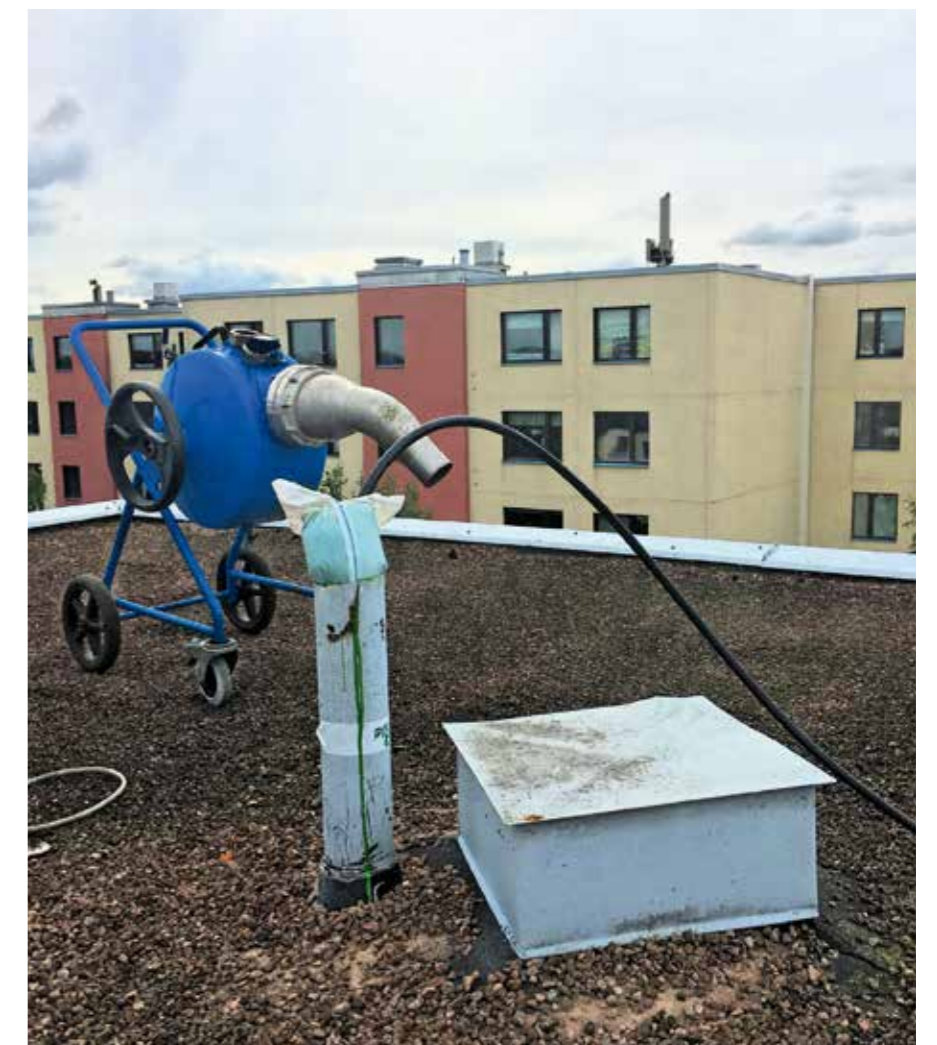
Figure 10: BRAWOLINER® inversion of a downpipe from the roof to the basement

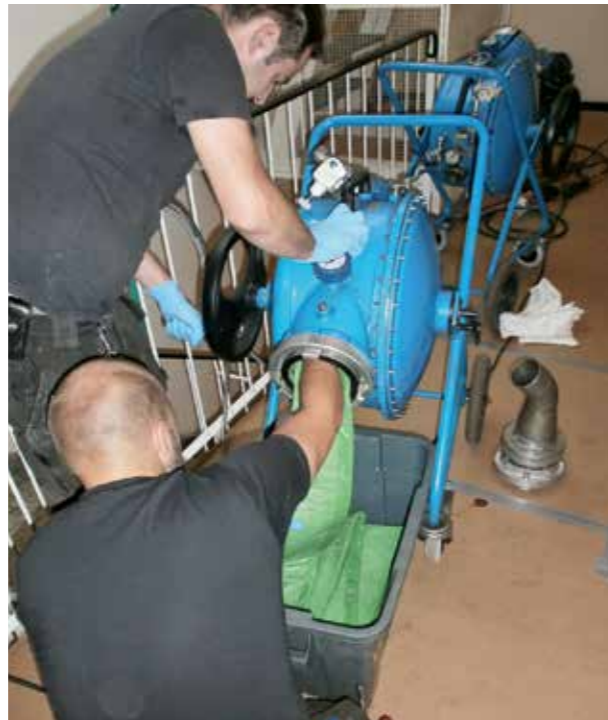
Figure 11: Liner inversion in the nominal diameter range DN 50 to DN 70 with a „liner gun“

The liners in the small side pipes are inverted on Picote construction sites with a specially developed „liner gun“ using the open-end method (see Figure 11). The liner ends are pre-glued with a specially designed cap, which is pulled by a tether once completely cured.

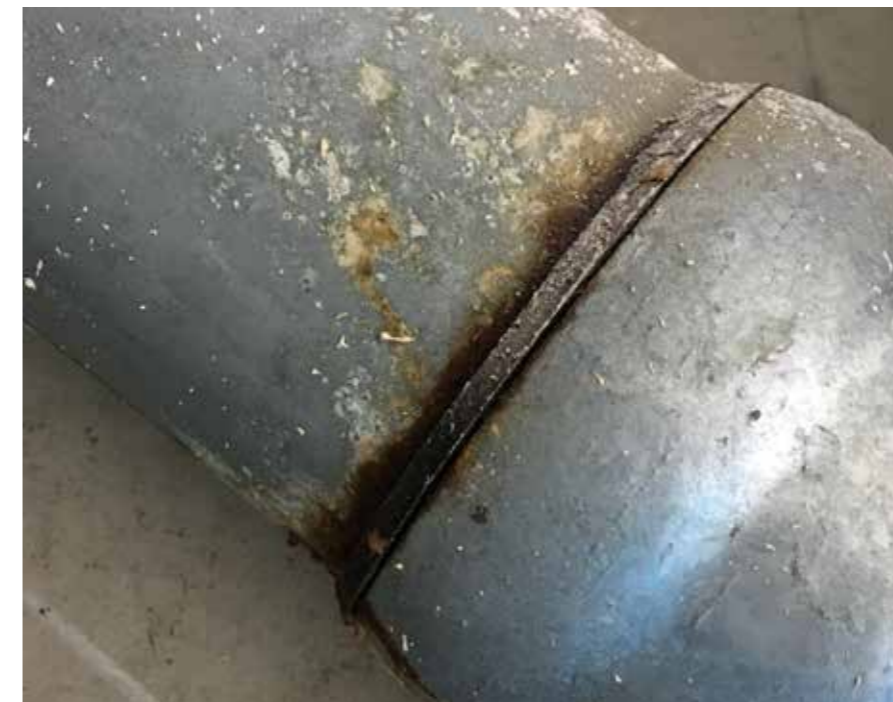
Corroded pipe connection in the steel pipe after around 50 years of use

For some time, owners have been repeatedly reporting damages caused by leaking waste water pipes. The downpipes exhibit cracks among other things as well as serious corrosion in many parts where the pipes are connected. The reports of damage have become increasingly frequent over recent months and years.

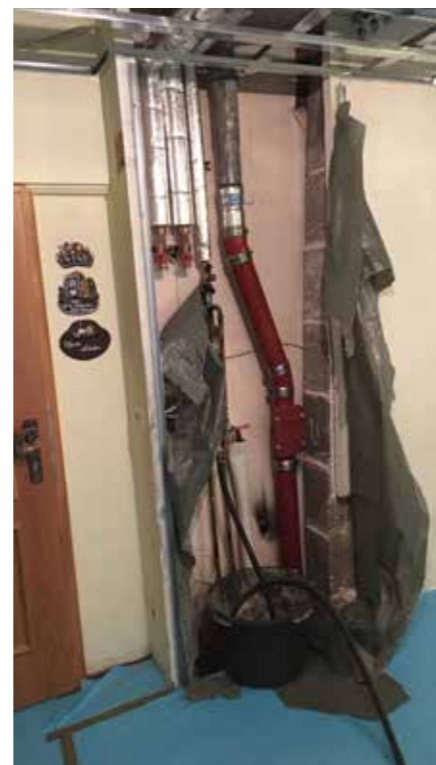
Newly created inspection openings on some intermediate floor levels of the holiday complex

on and liner progression are checked in the inspection openings on the intermediate floor levels. The inversion is finished as soon as the liner reaches the endpoint on the bottom floor.

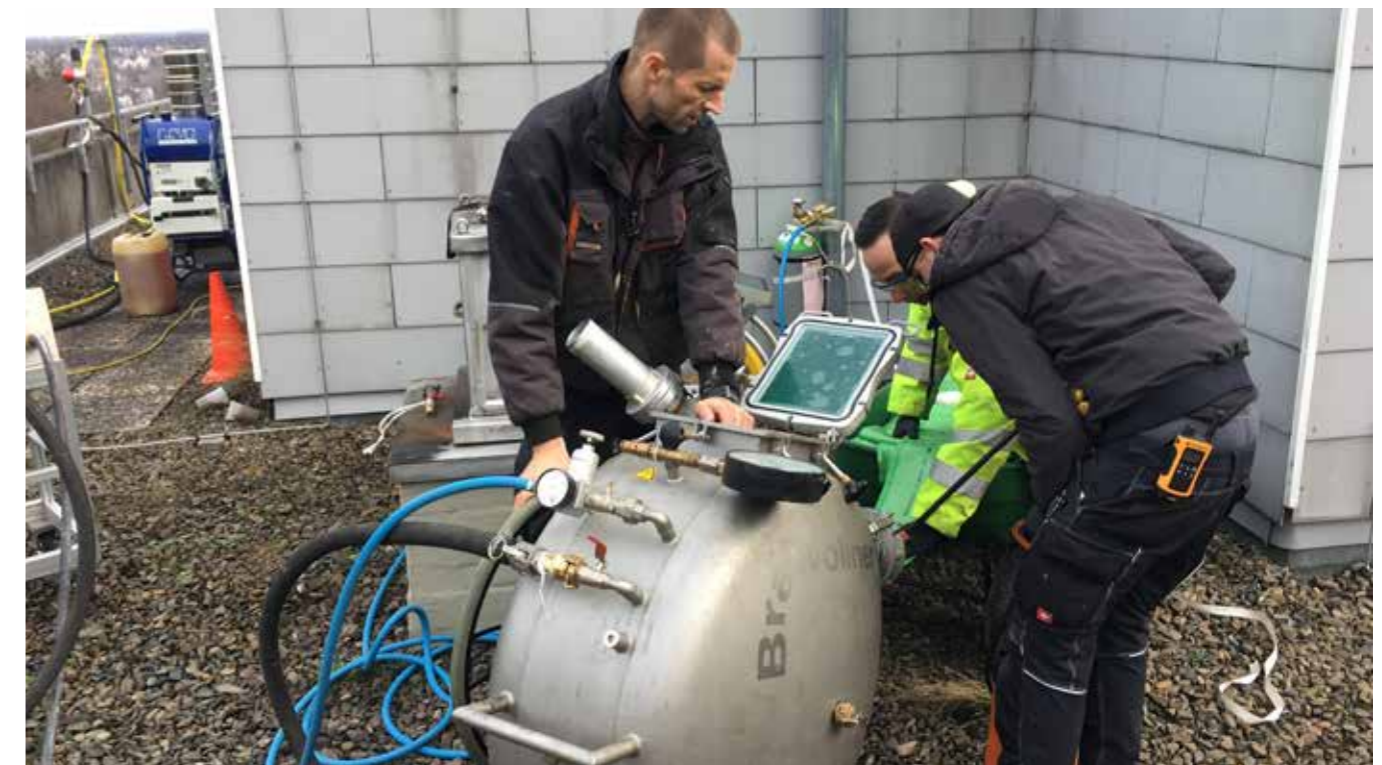
Inversion of the hose liner from the roof

**9:15 am:** The hose liner is brought onto the roof and the inversion started from top to bottom. The inversi-

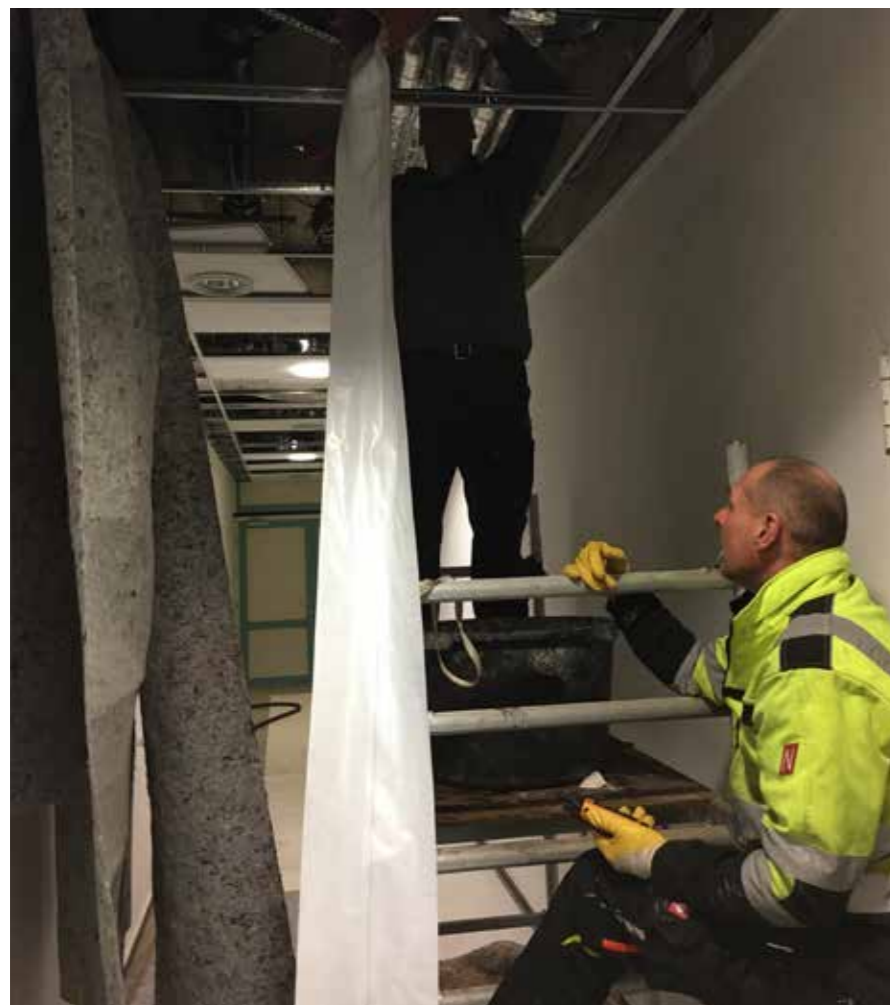
Hose liner arrived at the inversion end on the bottom floor

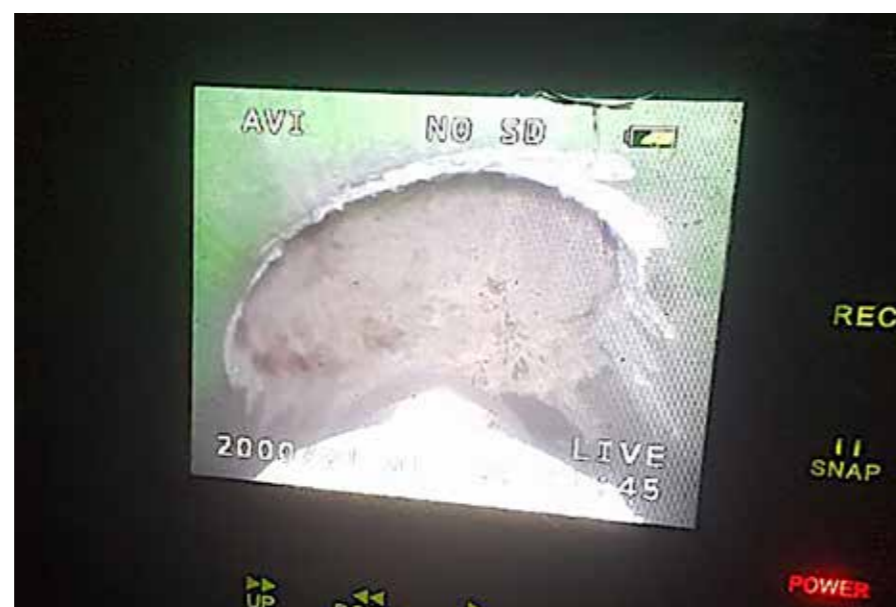
DN 100 inlet opened from a DN 125 downpipe with the cutting robot

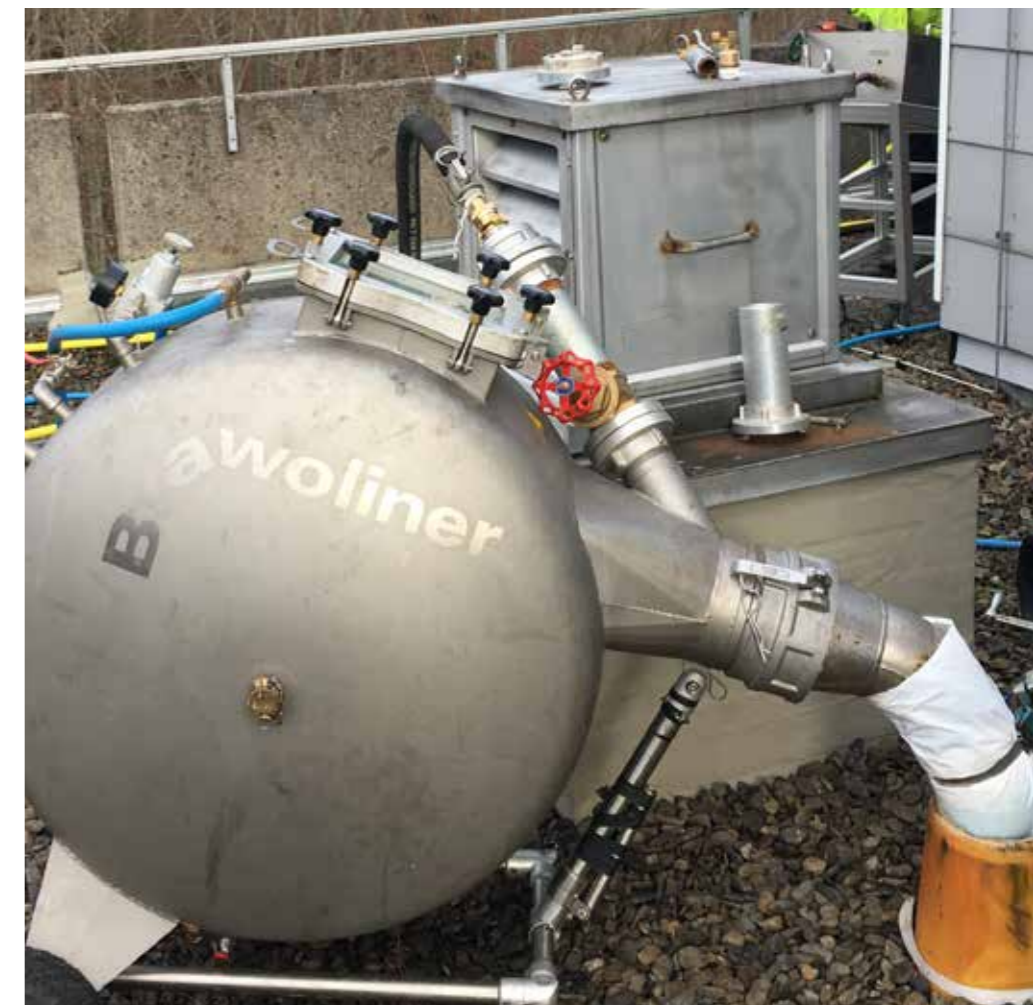
Steam curing the hose liner

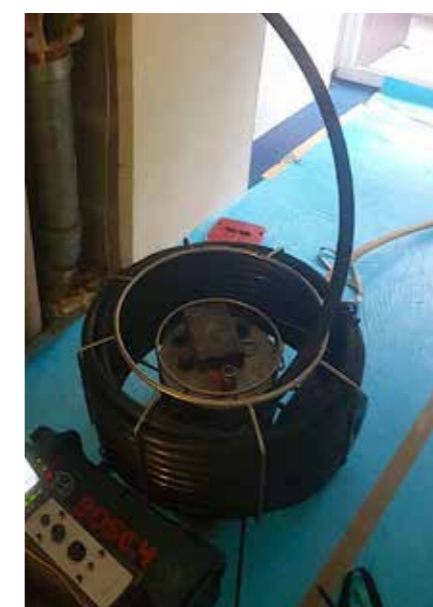
Using the cutting robot (IMS Robotics) in the DN 125 downpipe to open the inlets

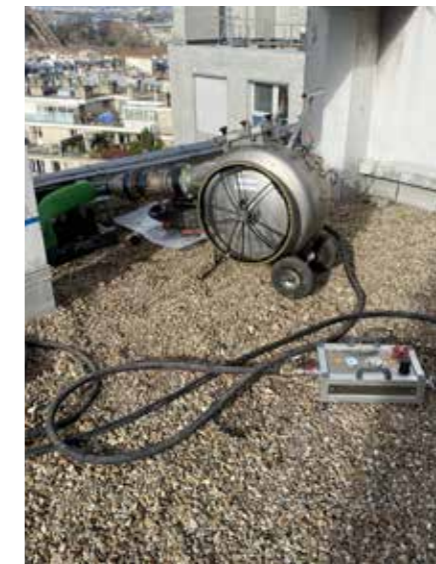
Control of the inversion with the BRAWO® Control Box

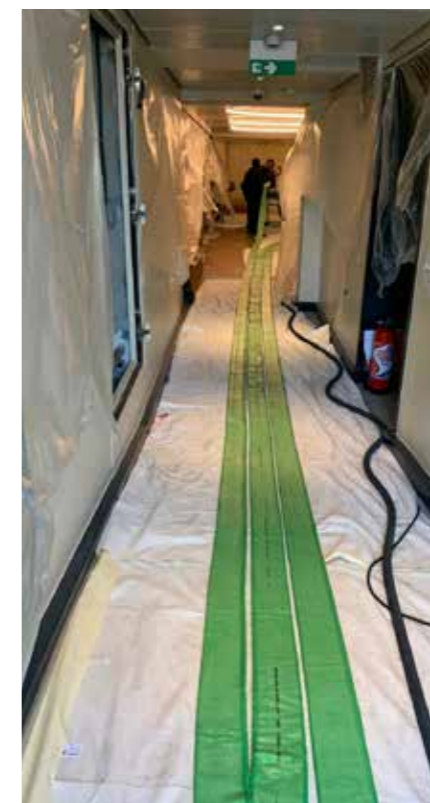
Impregnation of the 70 metres of BRAWOLINER®

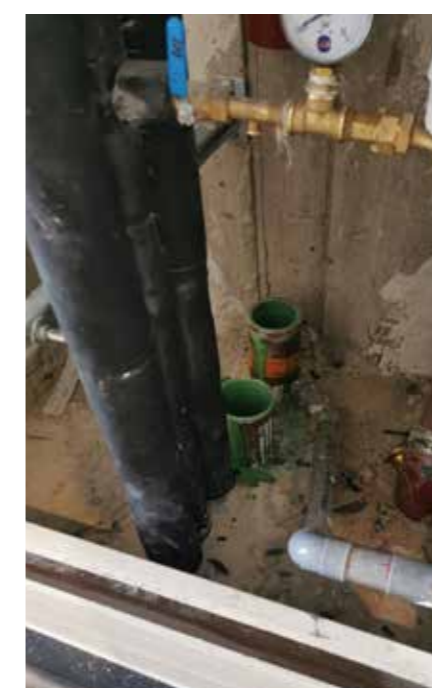
Lining of stag pipes from the top floor

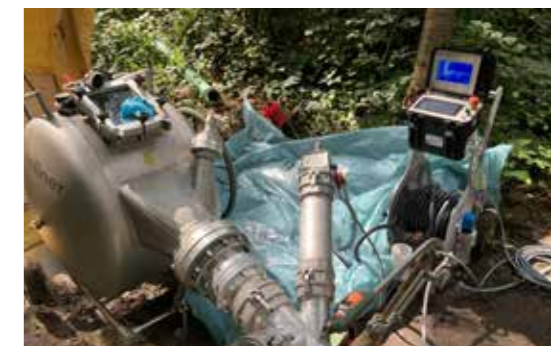
Curing process with the BRAWO® Magnavity

The innovative and unique LED heads allow simultaneous retraction with inversion of the liner. Curing is thus carried out immediately after installation of the liner, without the need for additional insertion of the eel.

Thanks to the 192 high-power UV LEDs and the associated greater light output, up to approx. 70% faster curing is possible compared to the Nano LED head. The Mega LED head is suitable for rehabilitating the dimension ranges DN 125 to DN 300. From a pipe diameter of DN 150 upwards, pipes with bends can also be rehabilitated economically and efficiently.

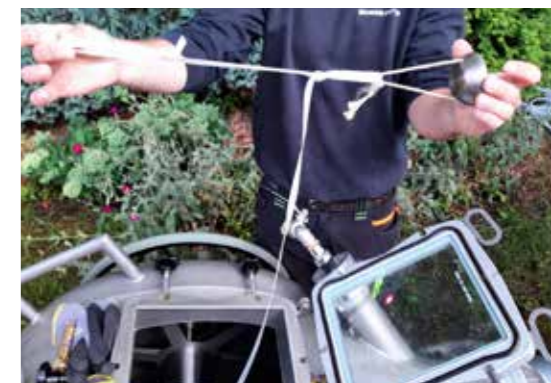
The steel cap enables decoupling of the MEGA LED head at the liner end
